**Flood Control Project Maintenance
Levee Inspections**
LMA District Cover Sheet
Spring 2011 Levee Inspection Results

Reclamation District No. 0070 Meridian

Levee Inspection Report By Mile - Spring 2011

Waterway						Bank	Unit Miles	Inspection Start/End	Inspector
Unit No. 01 Sutter Bypass						Right	8.00	04/05/2011 04/05/2011	Bob Duffey

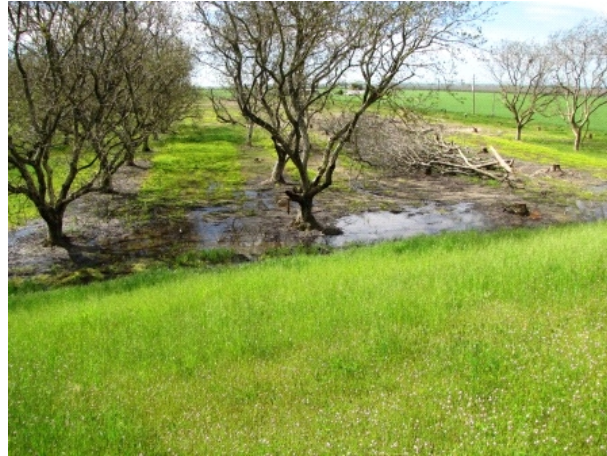
rduffey_s_20110427_293.jpg

Levee Mile Report Line	2
Start Levee Mile	3.27
End Levee Mile	3.27
Location	Land Side
Category	Earthen Levee
Item	Seepage / Sandboils

View of the seepage along the toe.

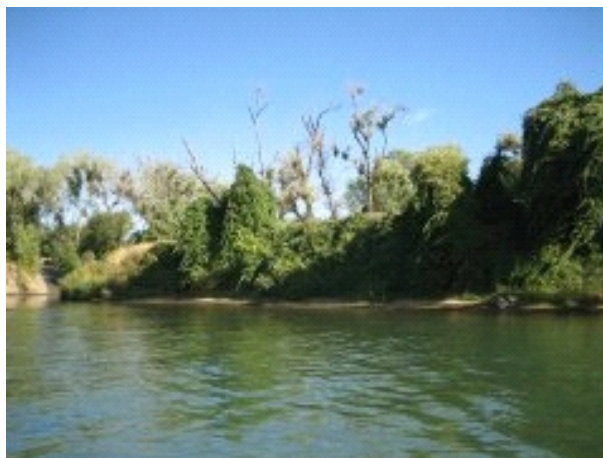
Levee Mile Report Line	1
Start Levee Mile	0.04
End Levee Mile	0.33
Location	Water Side
Category	Supplemental
Item	USACE Erosion Survey
2009: no berm, 1:1 slope, slumping, clays and silts, 2.58 ft/s [2009 SiteID:SAC_138-1_L]	
rduffey_s_20110228_091.JPG

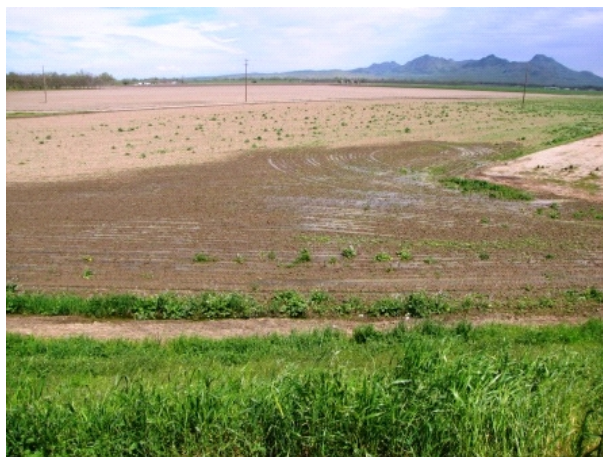
Levee Mile Report Line	2
Start Levee Mile	0.07
End Levee Mile	0.21
Location	Land Side
Category	Earthen Levee
Item	Seepage / Sandboils
View of the seepage along the toe.	
rduffey_s_20110427_294.jpg

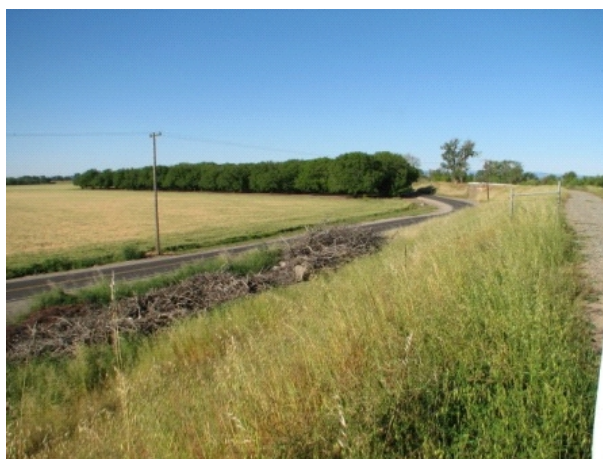
Levee Mile Report Line	3
Start Levee Mile	0.64
End Levee Mile	0.66
Location	Land Side
Category	Earthen Levee
Item	Encroachments
View of the pruning and debris along the landside toe.	
rduffey_s_20110228_090.jpg

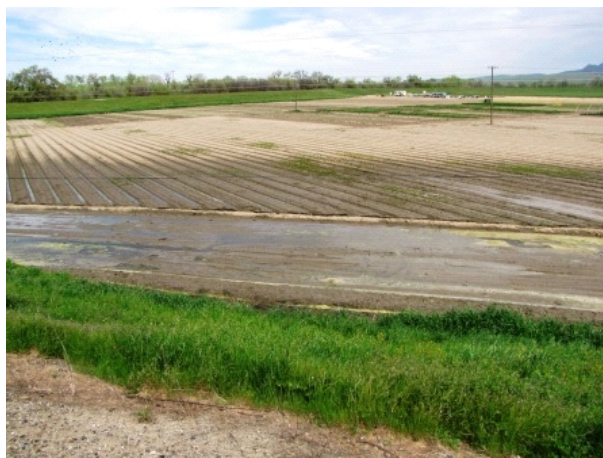
rduffey_s_20110427_295.jpg

Levee Mile Report Line	4
Start Levee Mile	1.38
End Levee Mile	1.38
Location	Land Side
Category	Earthen Levee
Item	Seepage / Sandboils

View of the seepage along the toe.

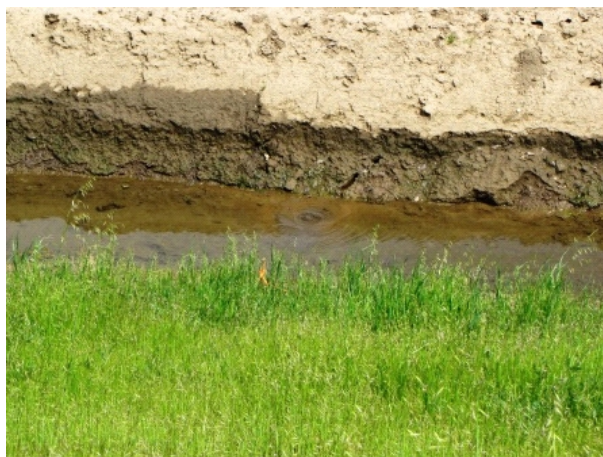
rduffey_s_20110427_296.jpg

Levee Mile Report Line	5
Start Levee Mile	2.21
End Levee Mile	2.21
Location	Land Side
Category	Earthen Levee
Item	Seepage / Sandboils

View of the seepage & Boils along the toe.

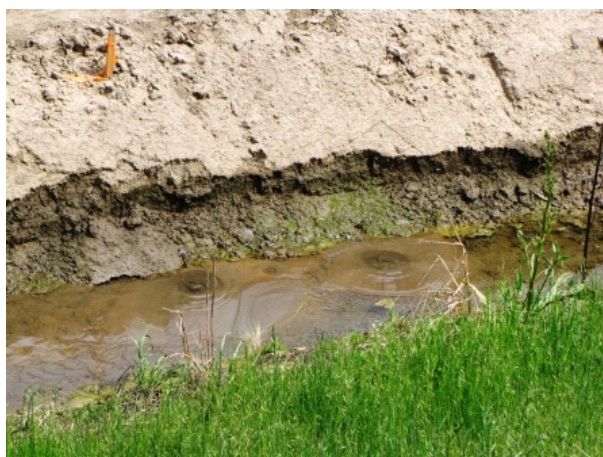
rduffey_s_20110427_297.jpg

Levee Mile Report Line	6
Start Levee Mile	2.33
End Levee Mile	2.33
Location	Land Side
Category	Earthen Levee
Item	Seepage / Sandboils

View of the seepage & boils along the toe.

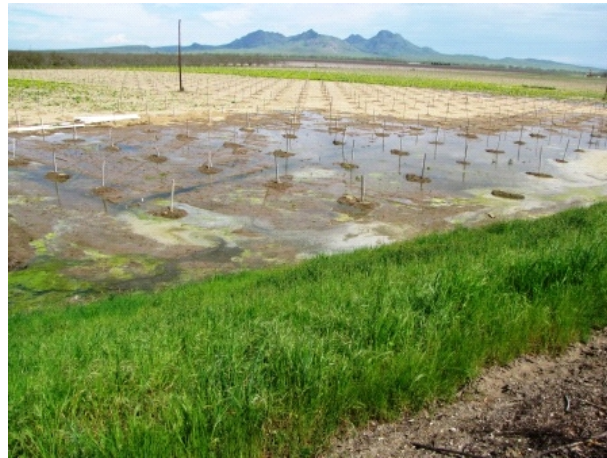
rduffey_s_20110427_298.jpg

Levee Mile Report Line	7
Start Levee Mile	2.95
End Levee Mile	3.05
Location	Land Side
Category	Earthen Levee
Item	Seepage / Sandboils

View of the seepage along the toe.

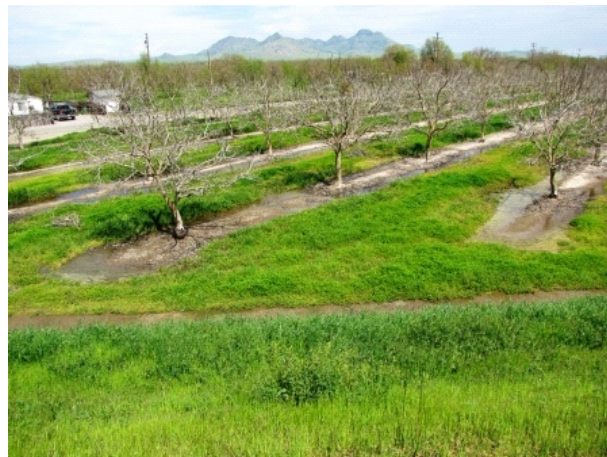
rduffey_s_20110427_299.jpg

Levee Mile Report Line	9
Start Levee Mile	3.63
End Levee Mile	3.63
Location	Land Side
Category	Earthen Levee
Item	Seepage / Sandboils

View of the seepage along the toe.

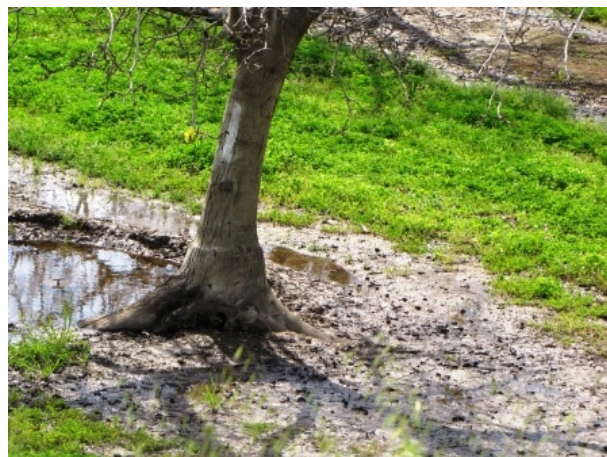
rduffey_s_20110427_300.jpg

Levee Mile Report Line	13
Start Levee Mile	4.76
End Levee Mile	4.76
Location	Land Side
Category	Earthen Levee
Item	Seepage / Sandboils

View of the seepage along the toe.

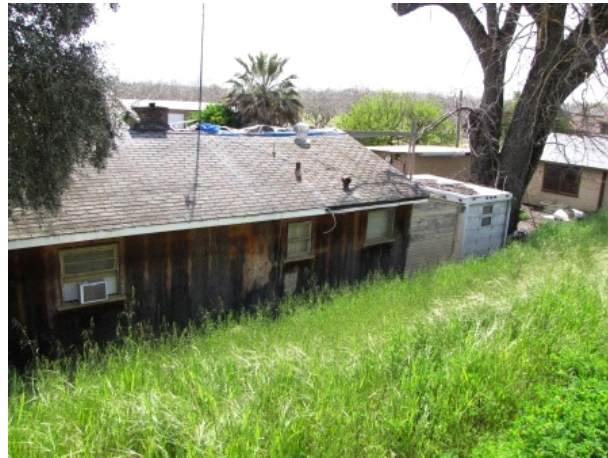
rduffey_s_20110427_301.jpg

Levee Mile Report Line	14
Start Levee Mile	4.99
End Levee Mile	5.02
Location	Land Side
Category	Earthen Levee
Item	Encroachments

View of the building along the toe.

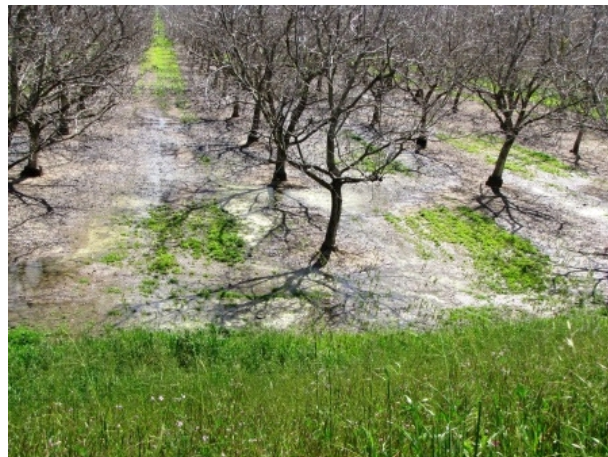
rduffey_s_20110427_302.jpg

Levee Mile Report Line	16
Start Levee Mile	5.10
End Levee Mile	5.10
Location	Land Side
Category	Earthen Levee
Item	Seepage / Sandboils

View of the seepage along the toe.

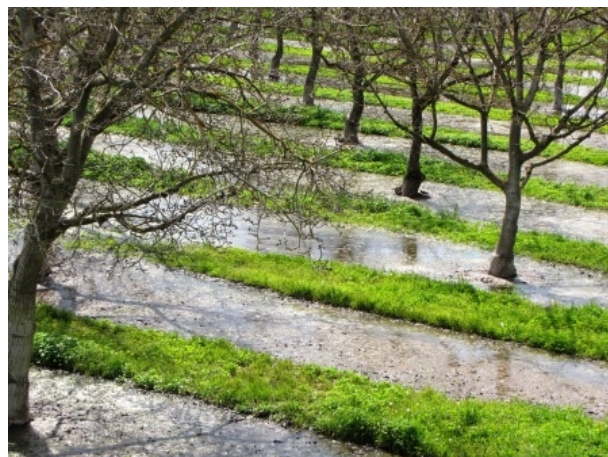
rduffey_s_20110427_303.jpg

Levee Mile Report Line	17
Start Levee Mile	5.14
End Levee Mile	5.47
Location	Land Side
Category	Earthen Levee
Item	Seepage / Sandboils

View of the seepage along the toe.

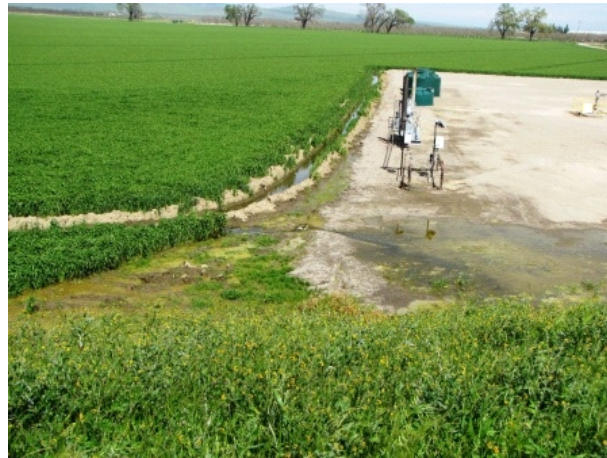
rduffey_s_20110427_304.jpg

Levee Mile Report Line	18
Start Levee Mile	5.47
End Levee Mile	5.84
Location	Land Side
Category	Earthen Levee
Item	Seepage / Sandboils

View of the seepage along the toe.

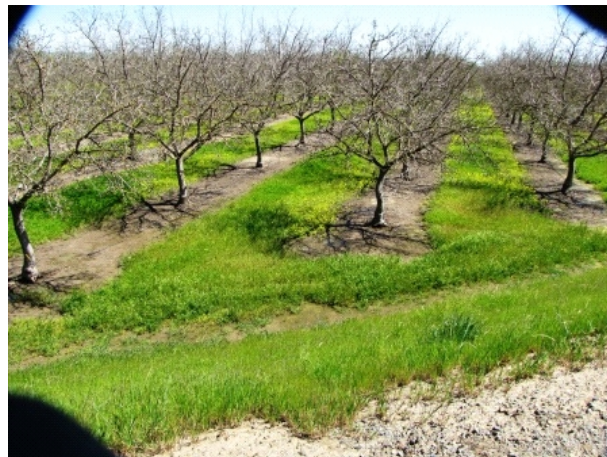
rduffey_s_20110427_305.jpg

Levee Mile Report Line	21
Start Levee Mile	7.25
End Levee Mile	7.25
Location	Land Side
Category	Earthen Levee
Item	Seepage / Sandboils

View of the seepage along the toe.

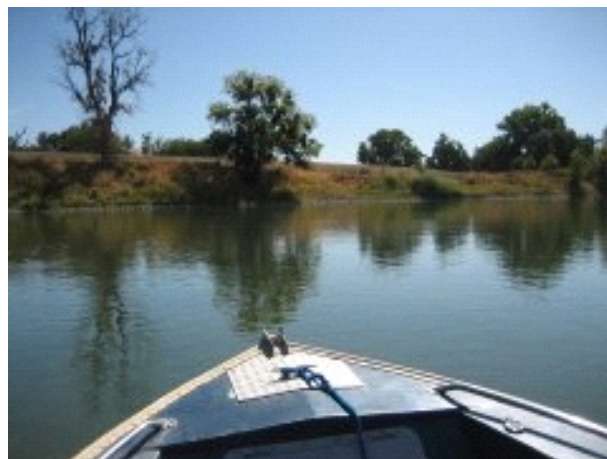
rduffey_s_20110228_092.JPG

Levee Mile Report Line	22
Start Levee Mile	8.16
End Levee Mile	8.26
Location	Water Side
Category	Supplemental
Item	USACE Erosion Survey

2009: no berm, 1.5:1 slope, tree hazards and slumping, clays and silts, 2.86 ft/s [2009 SiteID:SAC_130-0_L]

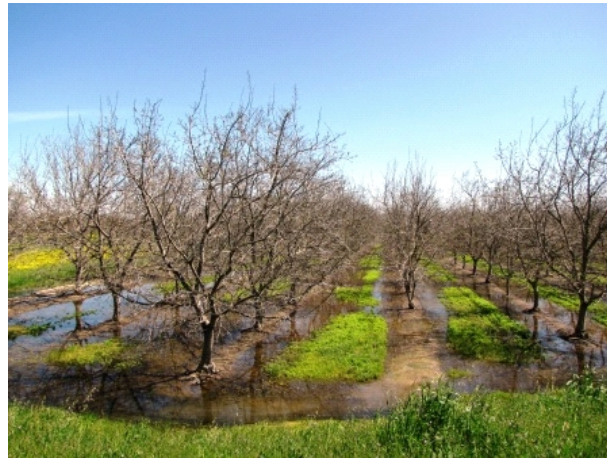
rduffey_s_20110427_306.jpg

Levee Mile Report Line	23
Start Levee Mile	8.66
End Levee Mile	8.71
Location	Land Side
Category	Earthen Levee
Item	Seepage / Sandboils

View of the seepage along the toe.

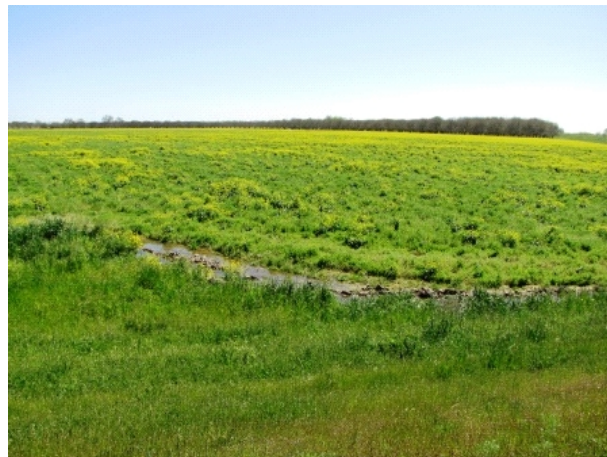
rduffey_s_20110427_307.jpg

Levee Mile Report Line	25
Start Levee Mile	9.86
End Levee Mile	10.97
Location	Land Side
Category	Earthen Levee
Item	Seepage / Sandboils

View of the seepage along the toe.

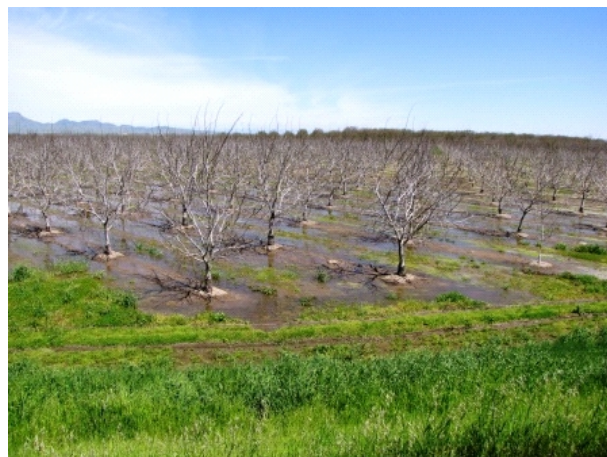
rduffey_s_20110427_308.jpg

Levee Mile Report Line	28
Start Levee Mile	11.80
End Levee Mile	12.35
Location	Land Side
Category	Earthen Levee
Item	Seepage / Sandboils

View of the seepage along the toe.

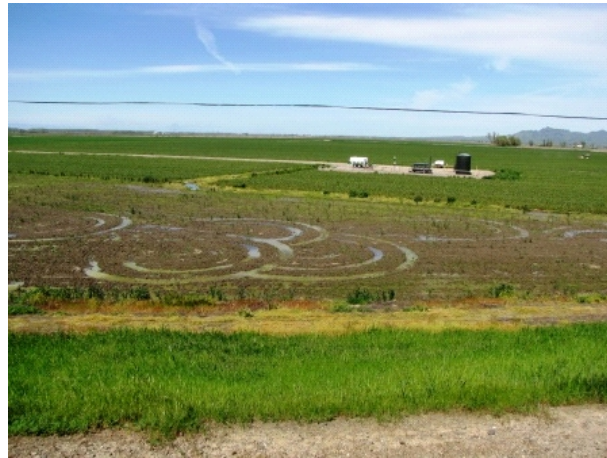
rduffey_s_20110427_309.jpg

Levee Mile Report Line	29
Start Levee Mile	13.22
End Levee Mile	13.22
Location	Land Side
Category	Earthen Levee
Item	Seepage / Sandboils

View of the seepage along the toe.

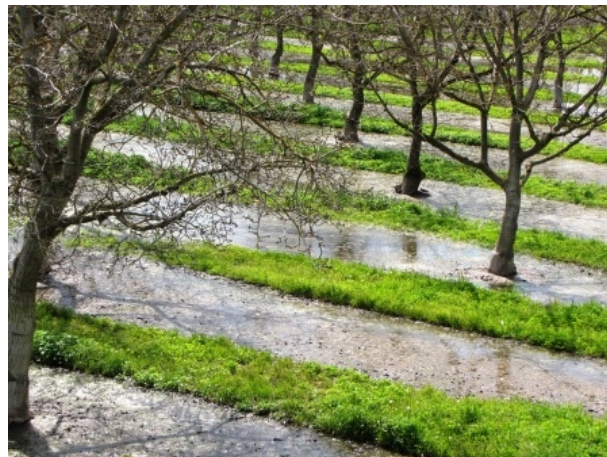
rduffey_s_20110427_312.jpg

Levee Mile Report Line	32
Start Levee Mile	14.48
End Levee Mile	14.48
Location	Land Side
Category	Earthen Levee
Item	Seepage / Sandboils

View of the seepage along the toe.

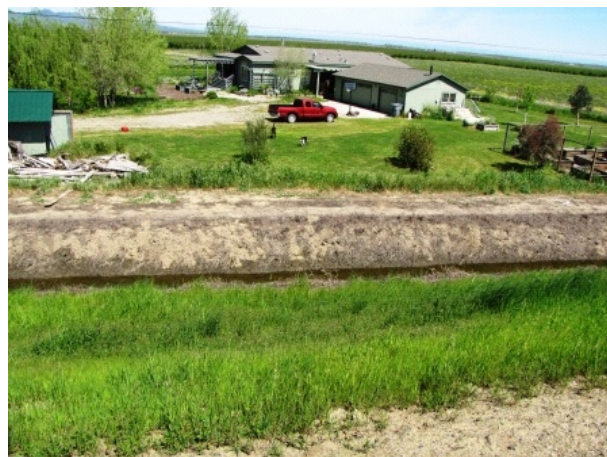
rduffey_s_20110427_310.jpg

Levee Mile Report Line	33
Start Levee Mile	14.71
End Levee Mile	14.77
Location	Land Side
Category	Earthen Levee
Item	Encroachments

View of the AG ditch along the L/S toe.

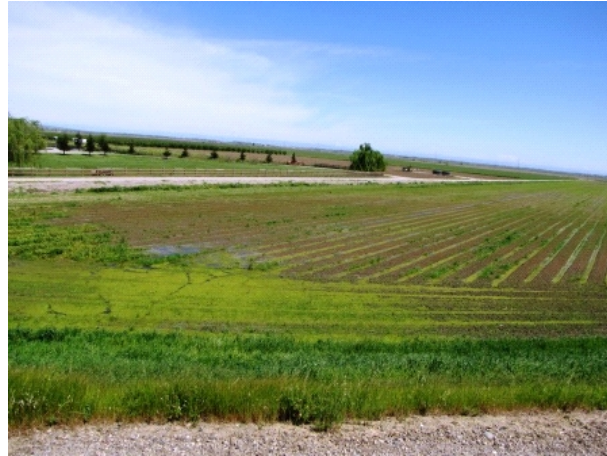
rduffey_s_20110427_311.jpg

Levee Mile Report Line	34
Start Levee Mile	14.89
End Levee Mile	15.32
Location	Land Side
Category	Earthen Levee
Item	Seepage / Sandboils

View of the seepage along the toe.
